DDASaccident452

DDAS Accident Report

SUBJECT: ATC DEMINING ACCIDENT ID NO E-04

Initial Demining Investigation Report

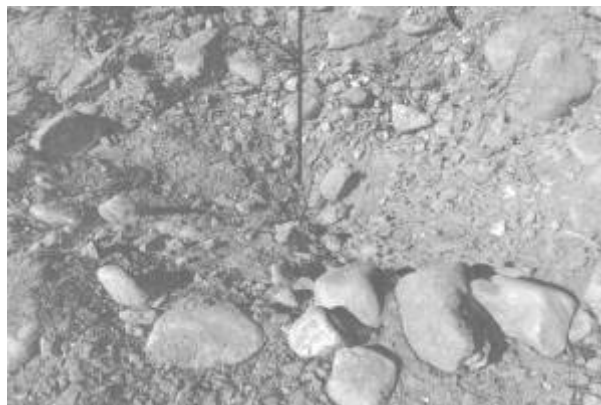
The ground was hard because of draught and sand.

[A photograph of the crater showed that the ground was rocky.]

The area has been observed by investigation team, and the area was uneven and hillside. The position of mine might be changed by floodwater.

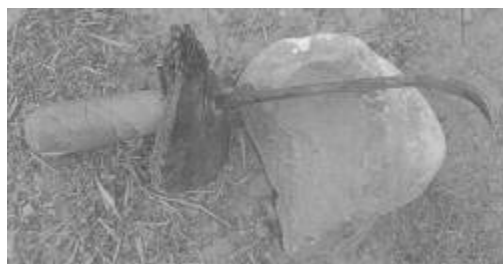
The primary cause of this accident is listed as “Unavoidable” because it seems that the Victim may have been working as directed when the accident happened. The locally made bayonet stayed in one piece and may have reduced the Victim's injury, but the deminers recognised that the use of the bayonet as an excavation tool may not have been the best choice. The use of the metal detector clearance in an area with a lot of metal fragmentation (and no strong magnets) may also have been unwise. The deminers wanted to prepare the ground mechanically but the machine was busy elsewhere. Because appropriate equipment and systems to conduct the task in safety were not in place, the secondary cause is listed as “Inadequate equipment”.

A photograph showed that the Victim's bayonet bent as designed and the hand-guard (the side-wall of a tyre) seems to have done its job. The Victim's hand injuries may have occurred when it was violently twisted from his hand.

I recommend: One Hitachi MDU to be sent to the area for preparation of the area for manual team. New equipments should be provided such as HF and VHF Radios and Visors.
